ANNUAL REPORT FOR 2008

Jeffreys Warehouse Stream Mitigation Site
Wayne County
TIP No. R-1030AA

Prepared By:
Natural Environment Unit & Roadside Environmental Unit
North Carolina Department of Transportation
November 2008

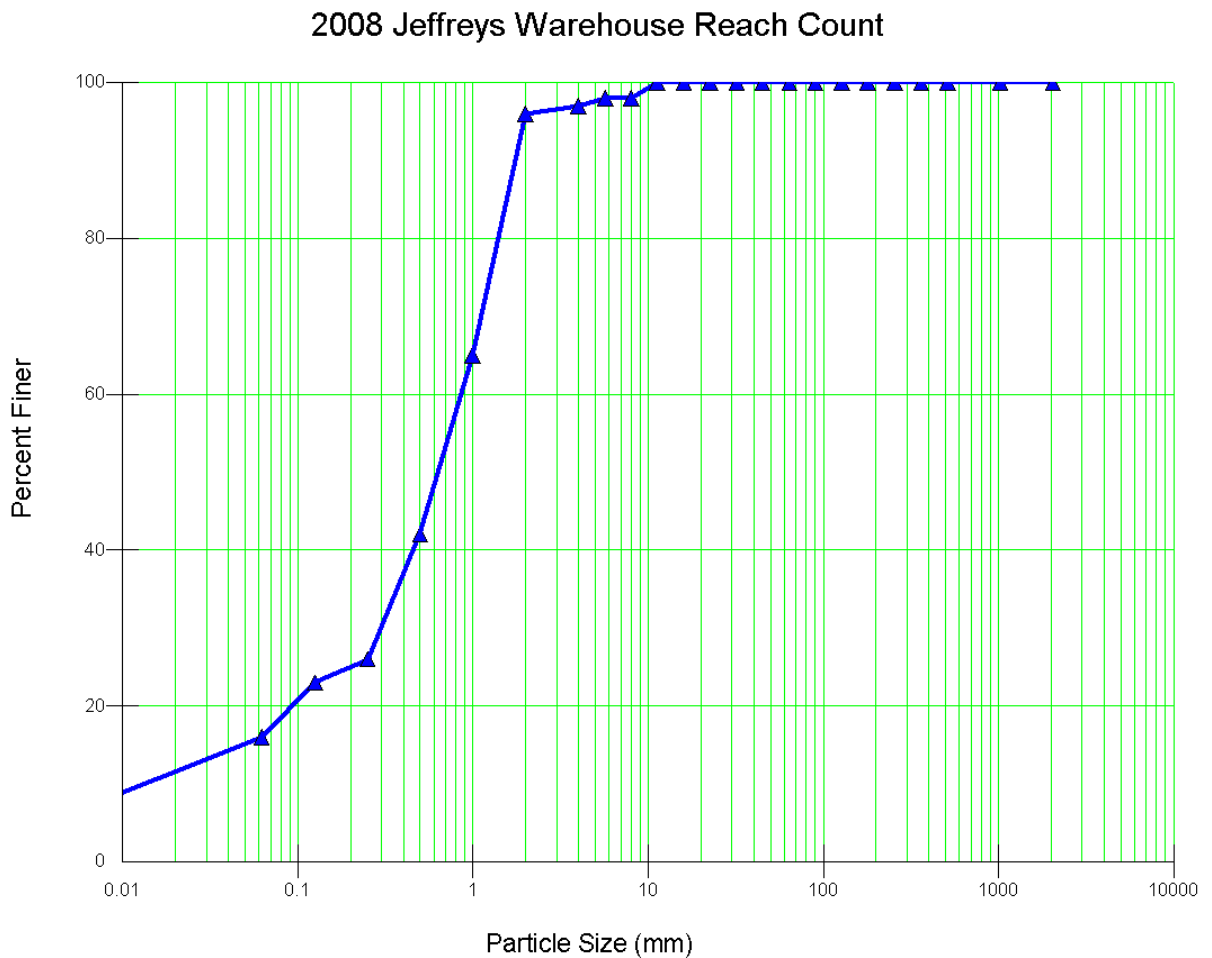
Chart 1. Particle Size Distribution for Entire Reach

A representative pebble count was taken throughout the surveyed reach. This information is used to determine the stream type. Jeffreys Warehouse Mitigation Site was designed as a sand bed system with the D_{50} being less than one. The pebble counts taken during the Year 2008 monitoring period noted that the D_{50} (50 percent of the sampled population is equal to or finer than the representative particle diameter) for the entire reach of Jeffreys Warehouse Mitigation Site was approximately 0.67 mm, which is indicative of a sand-bed stream.
